The Snyder Canal Slip: Its Development in Relationship to the Delaware & Hudson Canal and its Connections to the Natural Cement Industry.

Staff from the New York Museum conducted archaeological monitoring and data recovery in the southern portion of the Snyder Estate Natural Cement Historic District during the spring, summer and fall of 2011. The former Snyder Cement Works and Lawrenceville Cement Company were located along a small stretch of the D&H Canal that traveled through the hamlet of Lawrenceville (Figures 1 and 2). The Lawrenceville plant was known by several names throughout its long period of operation. these include the Lawrenceville Among Manufacturing Company (1858), Lawrenceville Hydraulic Cement Works (1887), Lawrenceville Cement Co (1892), W. T. Van Tassel Cement Co., and finally the Consolidated Rosendale Cement Co.

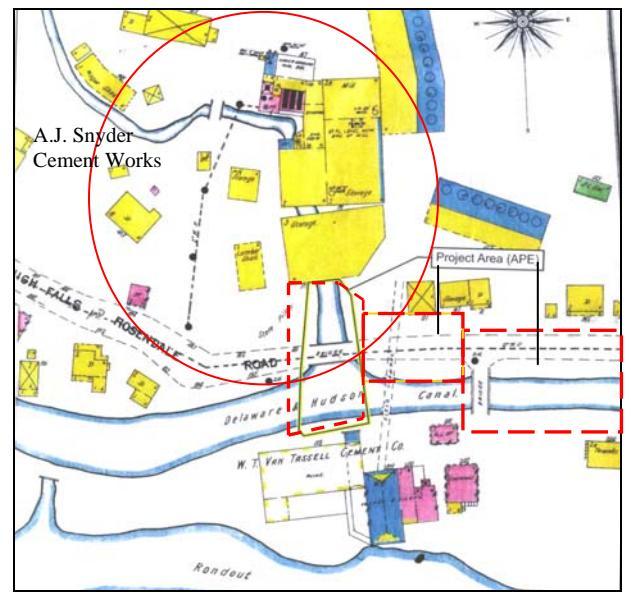
Figure 1. The 1904 Sanborn Insurance Map depicting the A. J. Snyder & Sons Cement Works and the Lawrence Cement Works under the ownership of W. T. Van Tassell Co. At this time the Snyder mill, kilns and storage building clustered in an area just north of the canal slip. An extensive storage building covered the northern end of the slip. The Lawrenceville Cement Co. ceased operation by 1904 and soon fell into ruins.

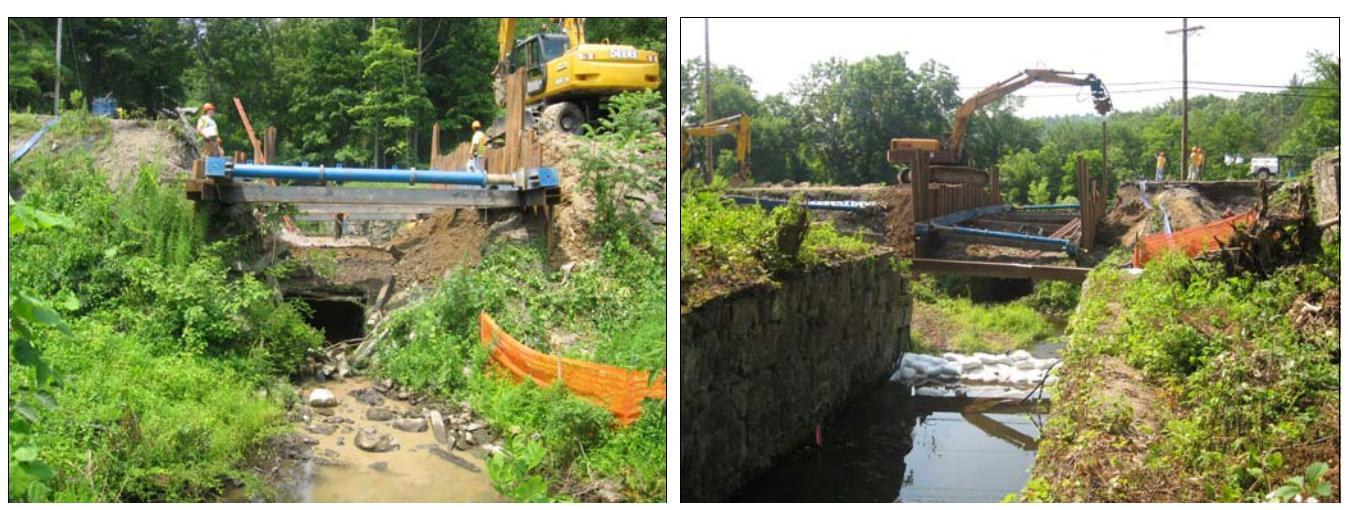
View of the outlet of the Snyder Canal Slip where it emptied into the canal.

Excavation exposing the top of the culvert as it rested in receiving basin portion of the slip.

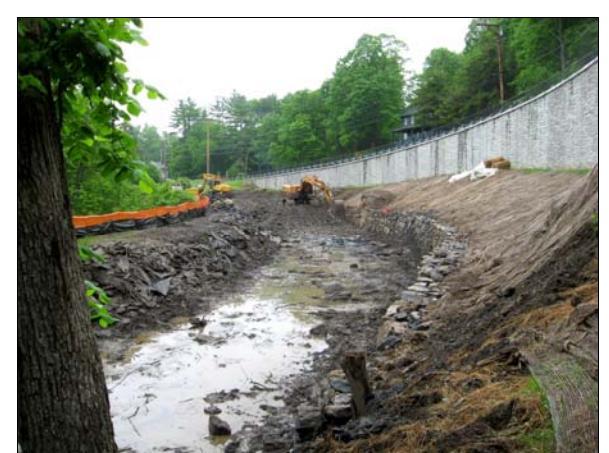
View west of the active removal of fill from the D& H canal

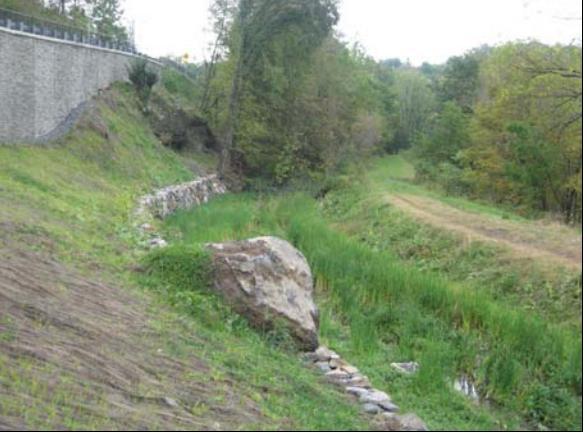
View of the canal after restoration, having a depth of nearly 6 feet.

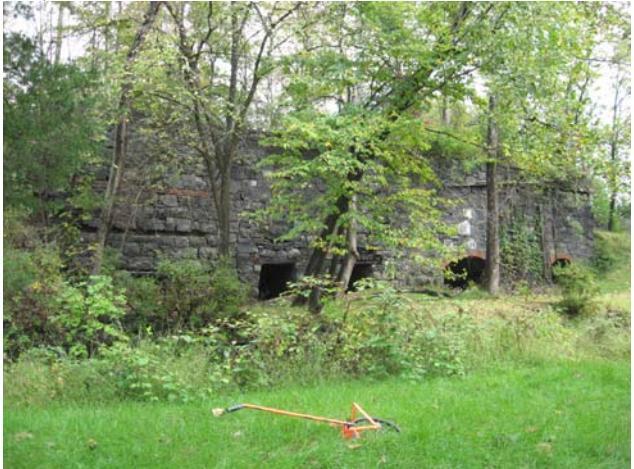
View of the early draw kilns and predecessors associated with the first cement works in Lawrenceville known as the Rosendale Cement Company (c.1827-1837).

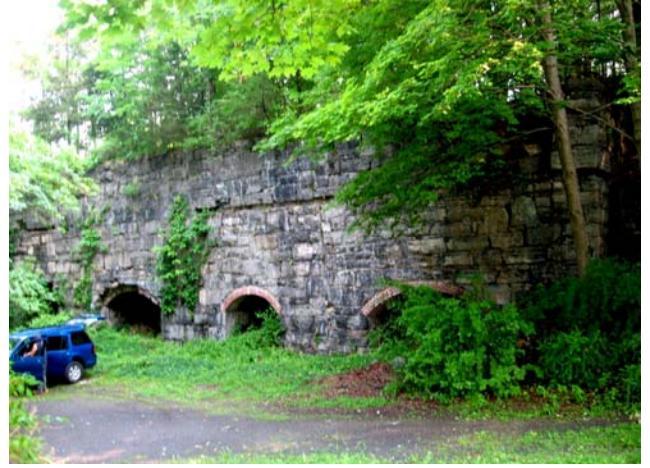
The Lawrence Kilns, originally constructed around 1837 when Lawrence started his second works, the Lawrenceville Cement Works. This battery is located adjacent to canal slip on the lands of Andrew J. Snyder (Sylvester 1880).

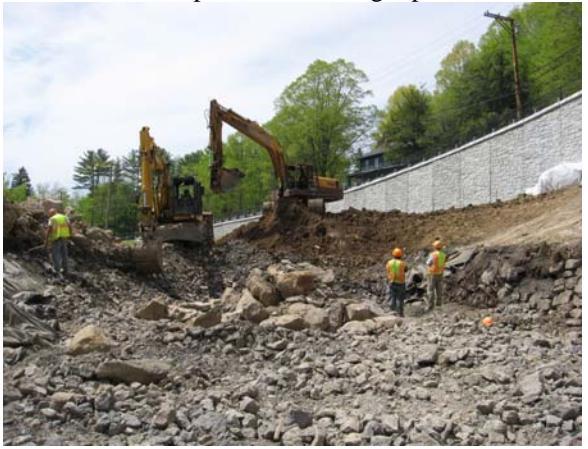
Monitoring of excavations in the canal. Intact portions of the berm wall are shown at right and sloped towpath at left.

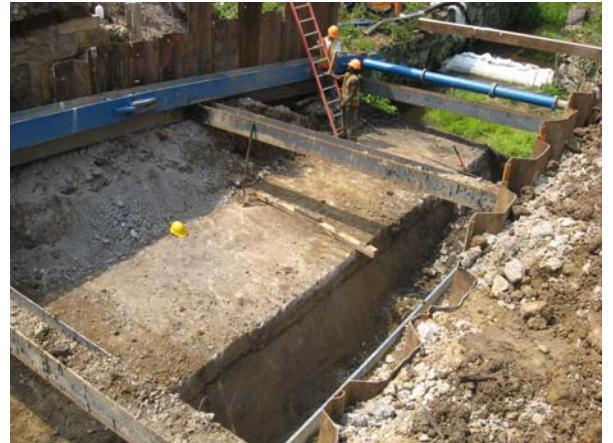
The removal of the roadbed revealed the top of the 1920s poured concrete culvert.

Due to the irregular terrain, repeated attempts were made to stabilize the roadbed of NY 213. In 2010 a slope failure occurred that undermined the highway. The canal was filled in to facilitate the road reconstruction that followed. Archaeological monitoring focused on two archaeological features, the National Register listed Snyder Canal Slip, and the portion of the National Register eligible Delaware Hudson Canal. Both of these are located in the Snyder Estate Natural Cement Historic District, a property listed on the National Register of Historic Places. The segment of the D &H Canal includes the basin where the canal slip emptied into the canal and a section that extends from the former highway bridge that crossed over the slip east through Lawrenceville to Lock 9. During archaeological monitoring, fill materials were removed and the canal was brought back to its former condition using original materials with some improvements. The 1920s culvert that was placed in the Snyder Canal Slip when the canal was abandoned was replaced with a larger pre-cast culvert.

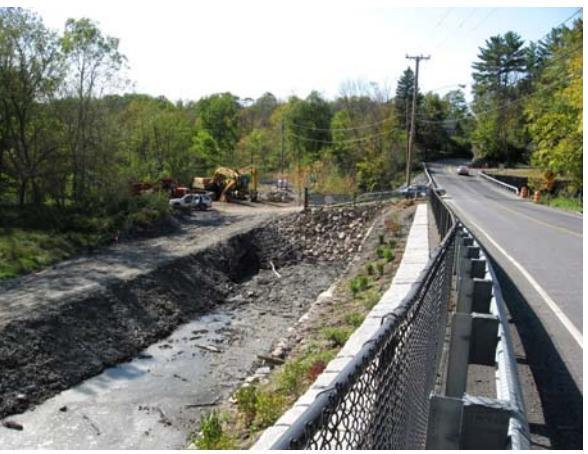
Completed excavation of the canal prism, west to the former canal bridge crossing.

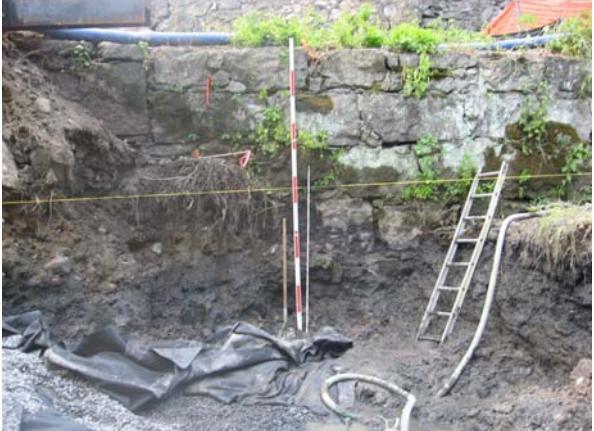
Final depth of excavation inside of the slip measured 11 ft (3.3 m) below top of the west wall of the slip.

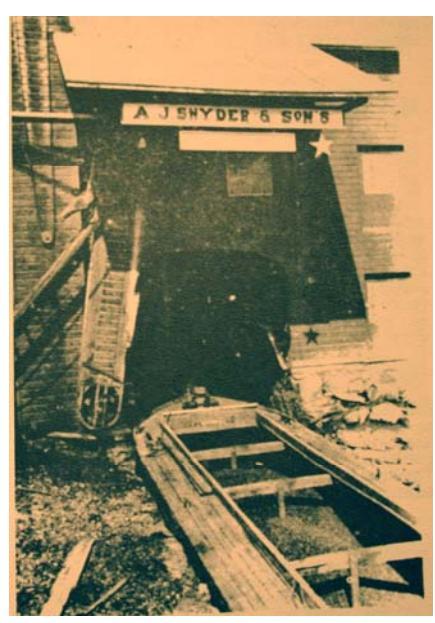
A boat is pictured in the slip at the southern entrance of the storage building (c.1900), possibly carrying a bulk shipment of coal. Note the stones lining the slip walls (Leroy 1950).

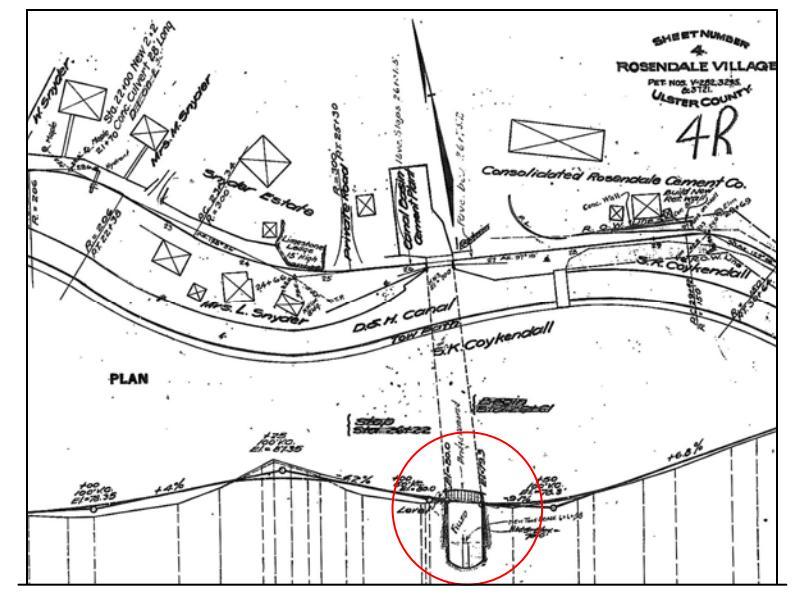
Figure 3. The 1916-1921 "as-built" construction plans depicting the construction of the culvert beneath the highway. The original plans were altered in 1920 in favor of removing the bridge; placing a culvert into the slip and filling it over (see profile in red circle).

A bridge has carried the highway (NY 213) over the slip since the late 1820s, crossing just inside of the wing walls of the entranceway in the receiving basin. The abutments held the deck of the bridge above the canal, the western abutment located just below the highway bed. This masonry structure was part of a continuous structure that linked the wing walls of the slip opening to the canal berm wall that lined the north side of the canal. The bridge abutment was approximately 18 feet wide, and crossed the width of the slip 28 feet. When the culvert was constructed (c.1920), the bridge was removed and the slip was filled leaving the abutments and slip walls in place (Figure 3).

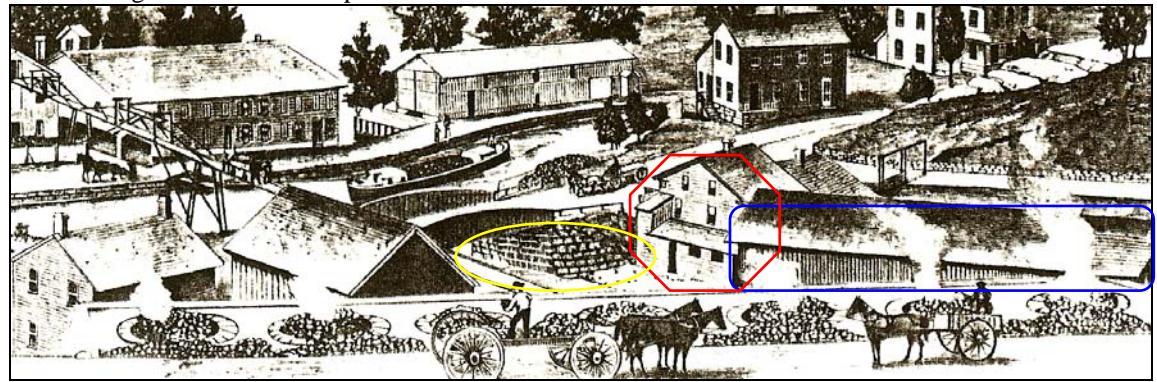
Figure 4. Lithograph c.1879 from *History of Ulster County* depicting the Lawrenceville cement works (looking south from the Lawrence Kilns). The mill is located on the south side of the canal and kilns used in association with the company in foreground. The Snyder works are positioned on the north side of the highway. The slip is circled in yellow, storage building in blue and Snyder Tenant House in red (From Wakefield 1992).

The canal slip was positioned in close proximity to an activity area once occupied by storage buildings, a wooden stave storage building, a tenement, coal storage, and the first of several tramway piers carrying fired limestone from the Lawrenceville kilns (Figure 4). A tight clustering of buildings and storage piles close to the slip facilitated the unloading of wooden staves, coal and the shipping of cement. A storage facility was constructed over the slip as early as the 1870s to provide coverage against the elements and house loading apparatus. The 1875 litho-graph shown below depicts the slip storage building and a residential 1½ story building, positioned on the west side of the slip identified as the Snyder Tenant House. The tenement was built into the slope rising west to a driveway that leads to the Snyder cement works. By 1892 the tenement was used for the storage of staves and may have functioned as a cooperage shop. The building was removed prior to 1898. The canal slip was filled in 1921, a highway culvert placed into the slip, and a roadbed built in place of the former bridge. This highway work occurred several years after the canal was abandoned and the slip was no longer used. Approximately 90 years later the culvert was replaced with a significantly larger structure designed to be capable of handling a 100 year flood event, evidently needed in August 2011 during the historic flooding of Hurricane Irene.

Other structures including a tenement and storage building associated with the Lawrence Cement Works, were located on the east side of the slip (Figure 4). A coal storage pile and tramway with masonry support pillars ran long the west side of the storage building in a relatively level and accessible area where supplies were unloaded by derricks set along the sides of the slip.

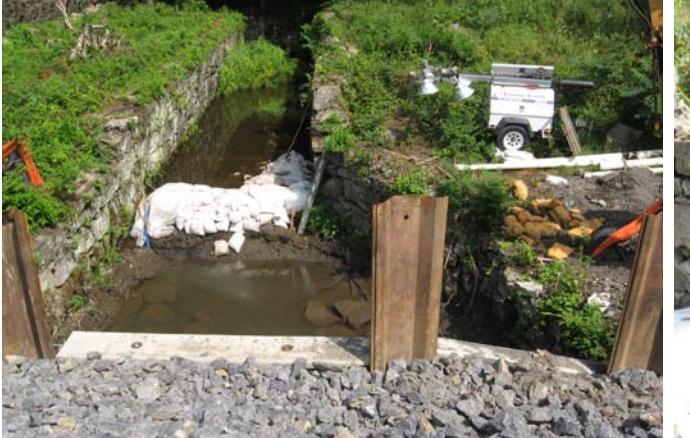
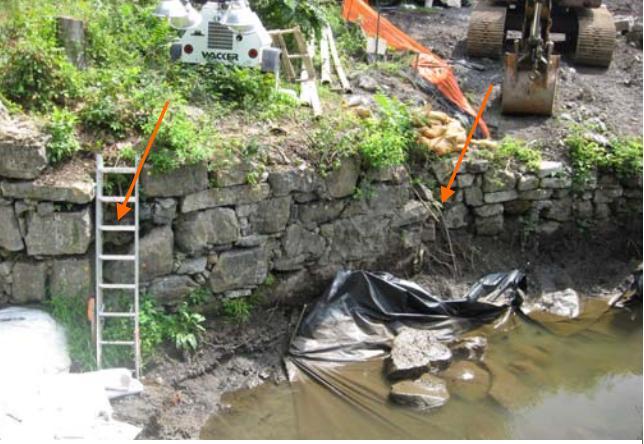
View north of the slip, showing the wide receiving basin and loading slip constructed of high parallel walls with uniform construction.

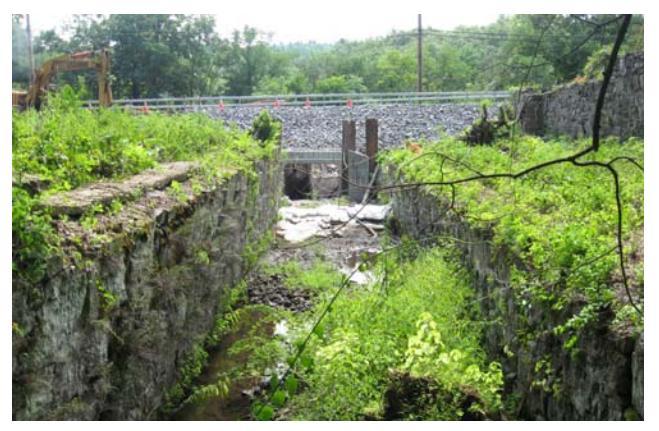
View south of the loading slip. Most of the walls remained intact with masonry elements of the loading and storage building, along its full length.

Study of the eastern wall of the slip in the receiving basin revealed at least two seams (see arrows), a variable construction technique and the use of different stones.

The bulk of the stone used in the construction of the slip consisted of rough-cut hewn stones of significant size. It was apparent that natural cement was used in many of the seams between the stones, particularly in the western wall and the lower wall courses of the eastern wall. The cement likely originated from the works of A. J. Snyder located adjacent to the site. The eastern wall of the slip near the transition between the receiving basin and the loading slip proved to be one of the most interesting features, showing evidence of different construction methods and materials (see photo above). A wooden beam was located at the base of the wall set into the grey clay that lined the base of the slip. The east wall was likely modified over time to accommodate to the barges used by the company. Additional wooden elements were observed in the west slip wall and along the receiving basin at its mid section. Wood planking was located just above the level of the bottom course of stone (see photos below).

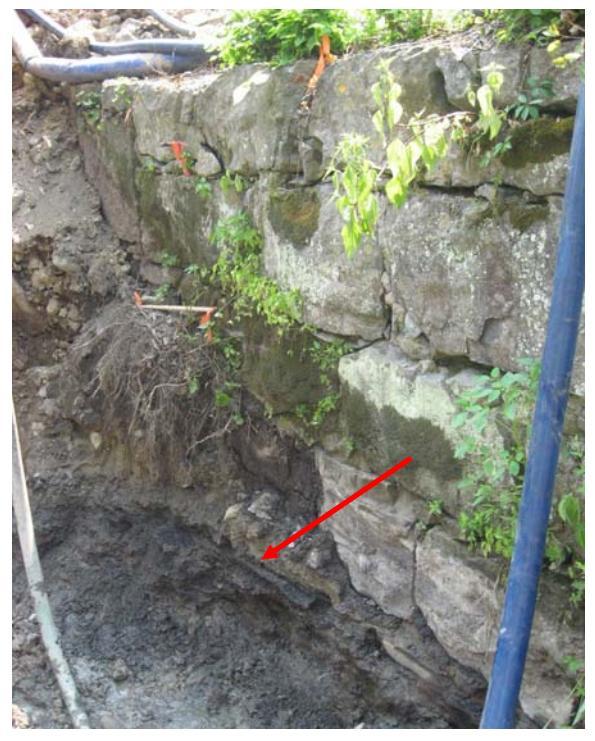
West wall of slip showing location of wood planking located 3 feet above base of excavation.

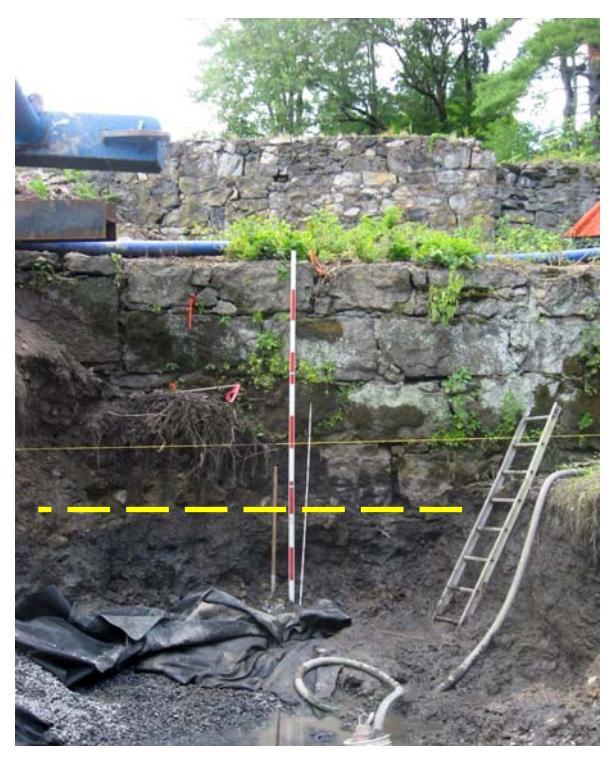
The full height of west wall of slip (11 feet) shown in foreground. Base of slip marked with yellow dashed line.

The top of the slip walls is located approximately 6.5 to 8.2 feet below the surface of the highway. After stream sediments were removed it was found that the eastern wall of the slip stood approximately 10 feet in height, the western wall measured slightly higher at 11 feet. Several feet of the wall lie below the clay at the base of the slip. The height of the slip walls was built to maintain a minimum of 6 to 7 feet of water in the slip channel, water supplied by both the Tan House Brook and the canal. The slip walls were higher inside of the storage building; having a total height of approximately 15 feet, measuring from 8 to 10 feet above the steam bed. Several of the stones in the upper course(s) were missing changing the height of slip walls since the time of its operation. The walls of the tenement rose 10.5 feet above the level area between the slip and the tenement. These walls were also constructed of roughly hewn and rumble stones with a natural cement binder, though they varied considerably from the slip wall construction, suggesting a different building period and or function.

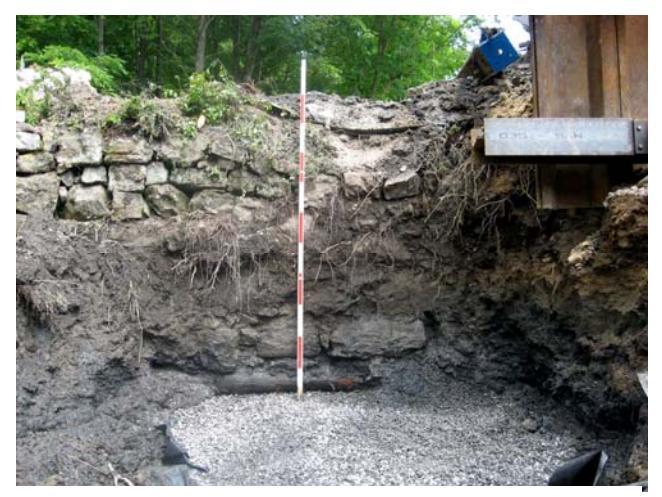
A unique construction technique was observed along east wall of slip. When excavated fully it measured 10 feet in height with the large roughly hewn stones used in the wall's lower four courses. The upper courses varied considerably, made of stone approximately 1/3 the size used in most of the slip. A wooden beam was located at the base of the wall in the clay layer.

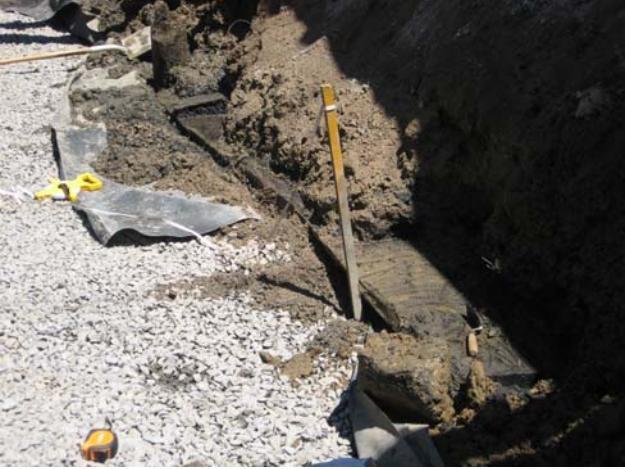
A wooden plank and post was located approximately 16 feet below the roadbed. The plank was 1 feet wide by 2 inch thick and traveled the base of the slip, approximately 5 feet from the slip's east wall. The plank is possibly the last remaining elements that formed the base of the slip in the receiving basin. The placement of the culvert in the 1920s had removed most of the material in this location.

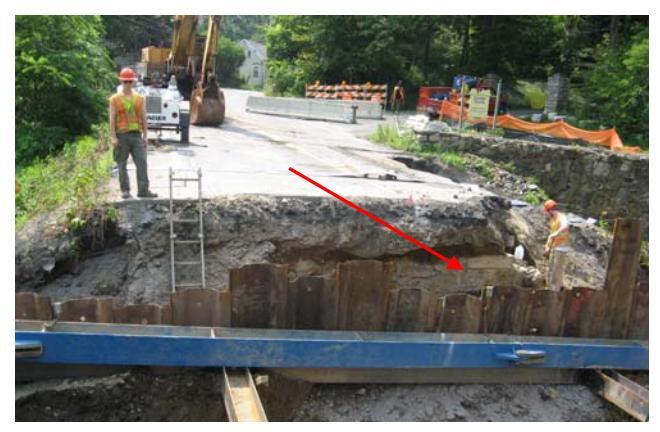
The western bridge abutment, made of rough hewn stones and cement, was located approximately 2.6 feet below the surface of the road.
